**TOWN OF CHAPLIN**  
**INSPECTION**  
**of**  
**BEDLAM ROAD BRIDGE**  
**over**  
**UNNAMED STREAM**

**Bridge No. 024004**

**MAY 20, 2019**

**Prepared by:**  
**Wengell, McDonnell & Costello**  
**-Consulting Engineers-**  
**87 Holmes Road**  
**Newington, Connecticut 06111**

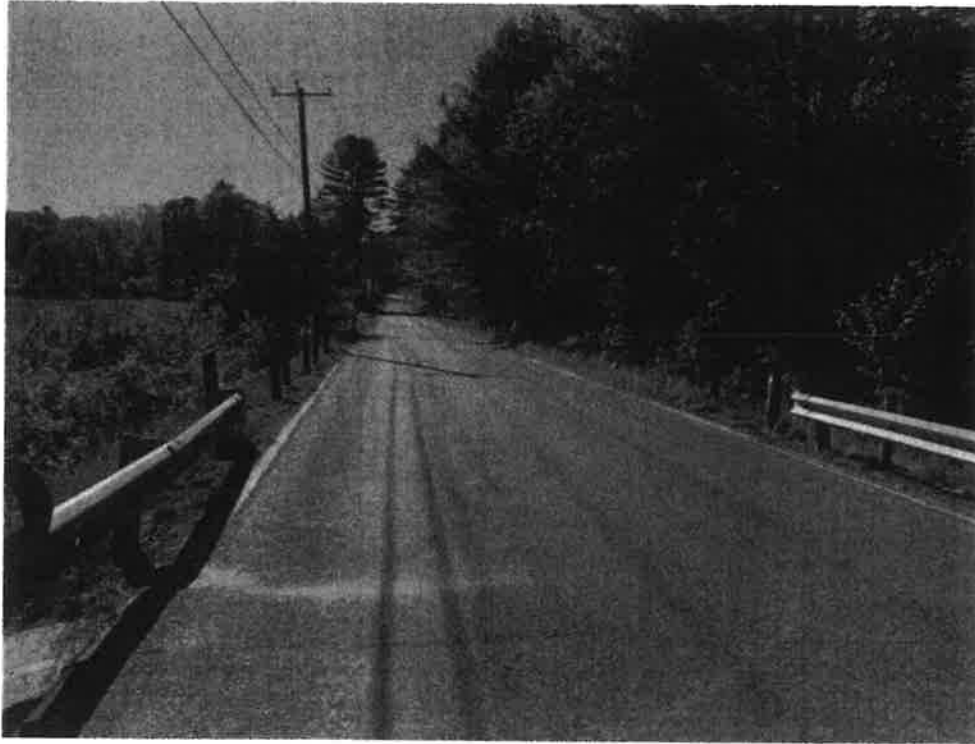
| | RATING | |
|---|---|---|
| APPROACH PAVEMENT | <input type="checkbox"/> 6 | Approach slab is satisfactory condition with minor longitudinal cracking. |

**Photo 1 - East Approach to Bridge (Facing West)**

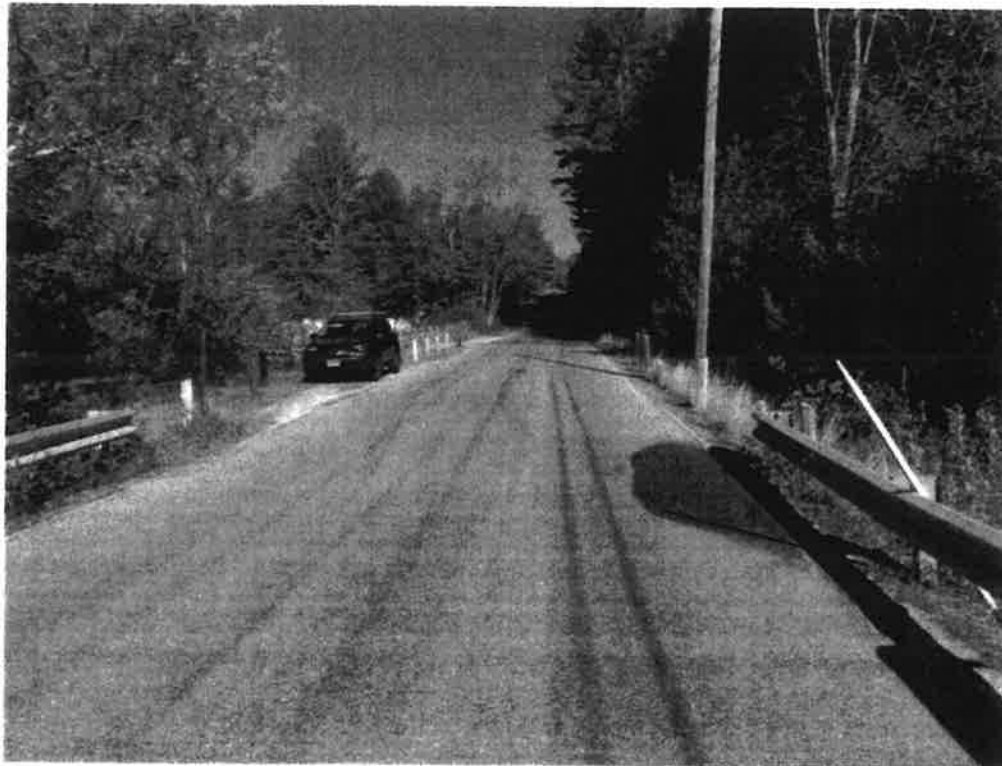
**Photo 2 - West Approach to Bridge (Facing East)**

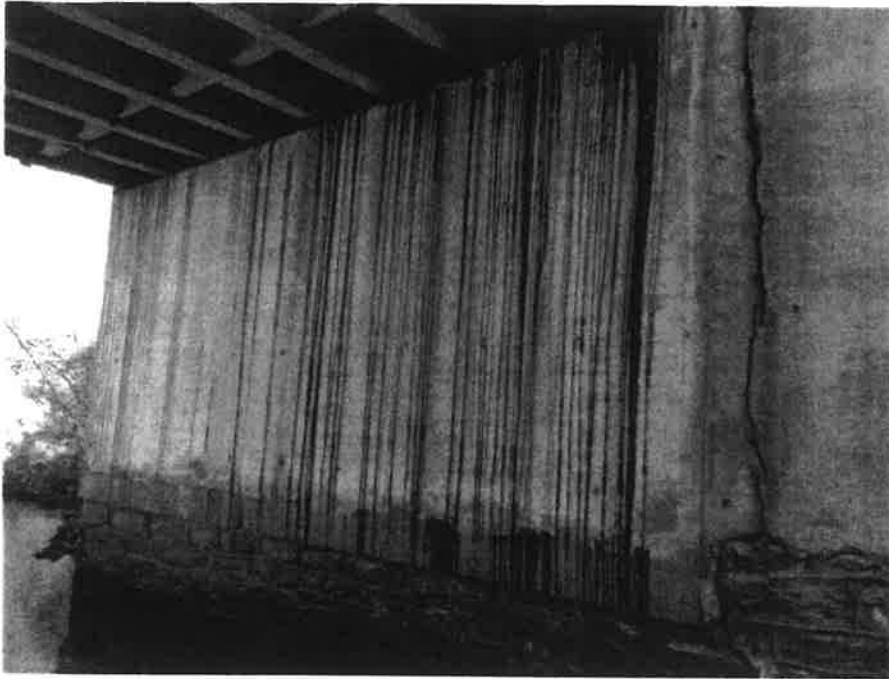
| ABUTMENTS-STEM | <input type="checkbox"/> | Abutments have some missing mortar, minor efflorescence and light scalling. All wingwalls have full height vertical cracks, in some parts about 3-4 inches wide with random spalls. There are full height vertical cracks causing separation between the wingwalls and west abutment. |

**Photo 3 – West Abutment**

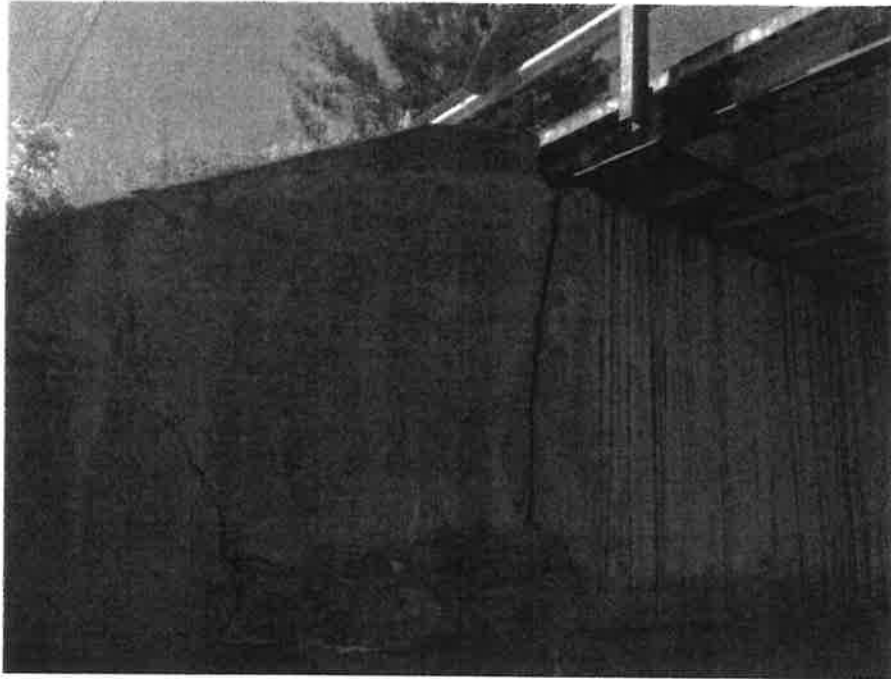
The Substructure is in Serious Condition (Condition Rating = 3). Mortar loss in stone abutment and wingwalls. There are full height vertical cracks from the bridge seat to the foundation on both abutments at both ends. There are also full height vertical cracks in the wingwalls. There are stone missing and minor efflorescence leakage is noticed in both wingwalls and abutment as well.

**Photo 5 – Northwest Corner/West Abutment  
Large Vertical Crack and Tilted Wingwall**

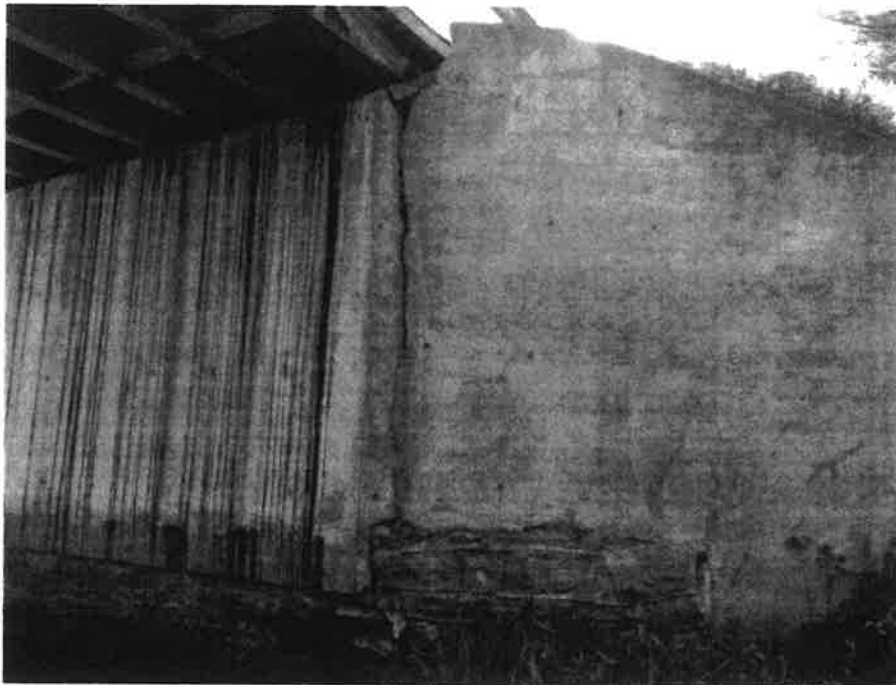
**Photo 6 – Southwest Corner/West Abutment  
Large Vertical Crack and Missing Stones**

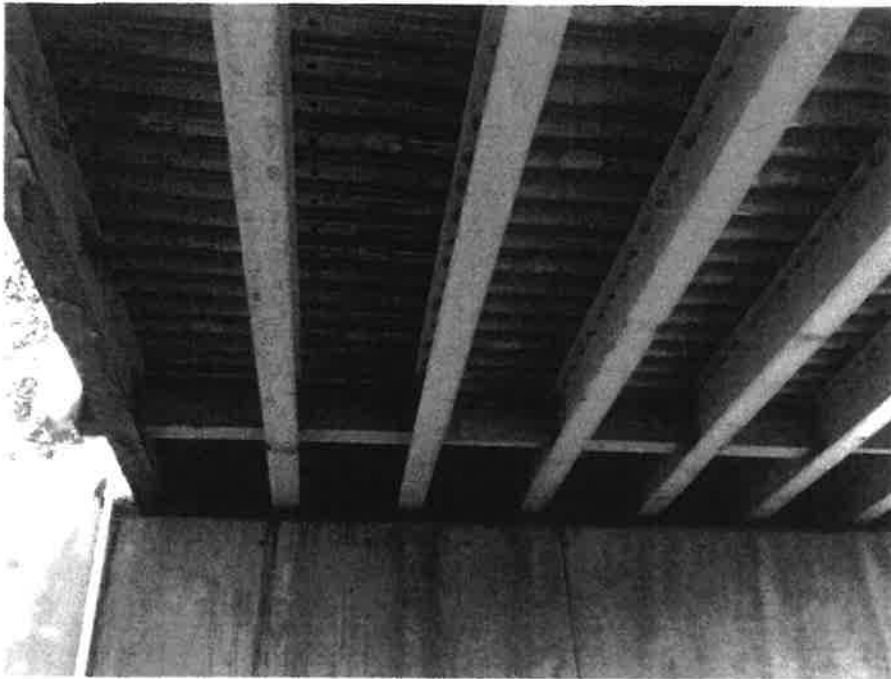
The Superstructure is in Fair Condition (Condition Rating = 5). It consists of a concrete deck slab. Both facial beams have rusting along the beams and moderate rusting at both ends due to moisture. No section loss was observed.

| | RATING | |
|---|---|---|
| GIRDERS | 6 | Facia girders exhibit moderate rusting all around and at each end. |

**Photo 7 – Under the Bridge, Rusted Exterior Beam**

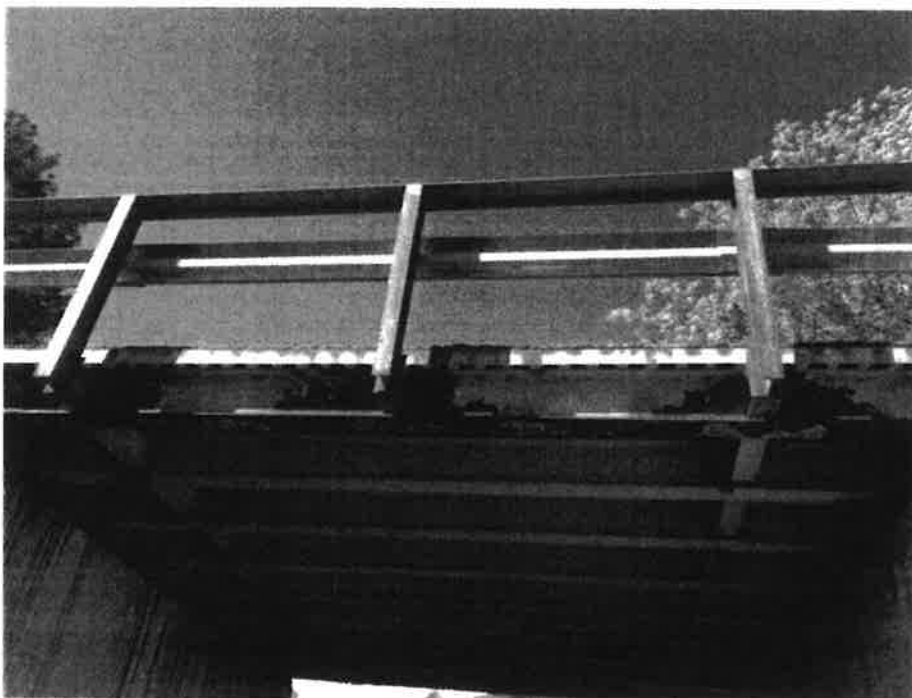
**Photo 8 – Upstream Fac, Rusted Exterior Beam**

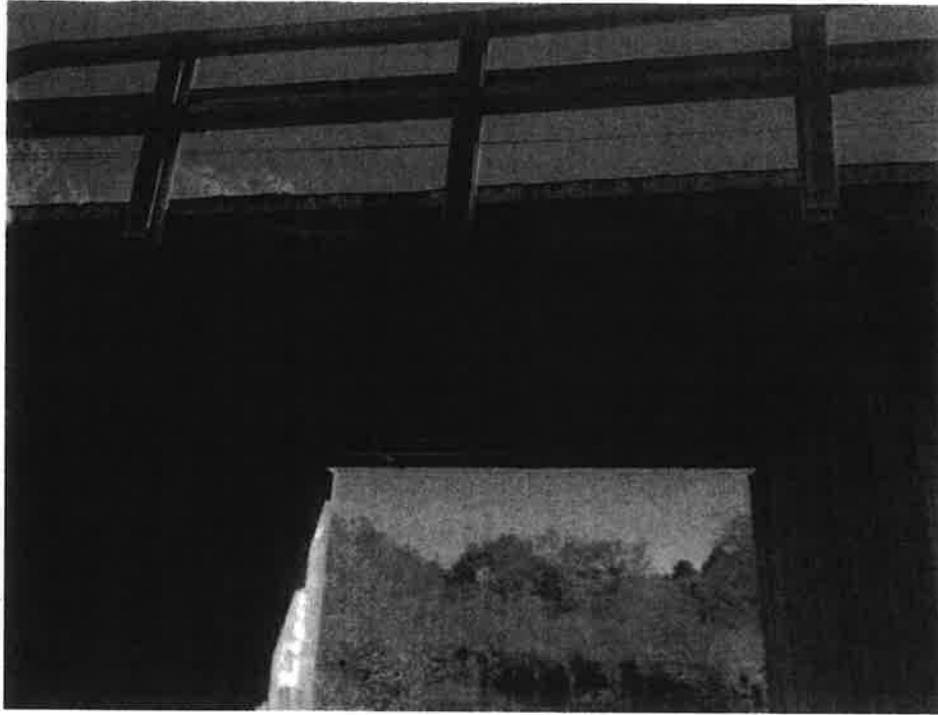
**Photo 9 – Downstream Face (Looking Upstream)**

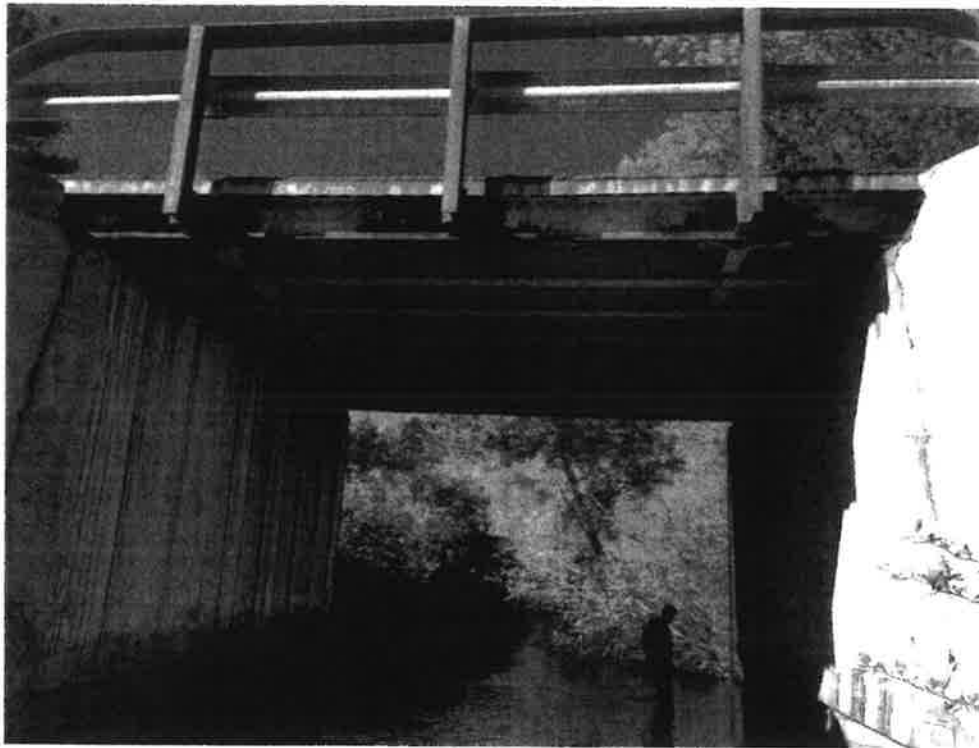
| DEBRIS | <input type="checkbox"/> | On the upstream side dead trees and branches have created a pond. |

**Photo 10 – Upstream Face (Looking Downstream)**

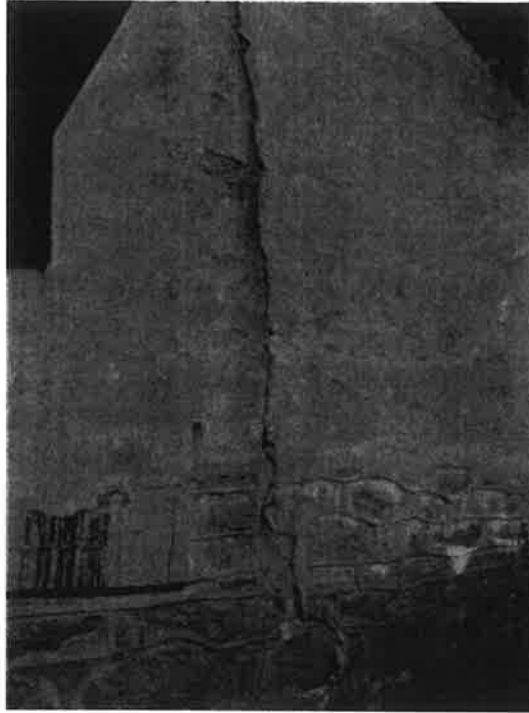
**Photo 11 – Northeast Corner, Large vertical crack in the wingwall**

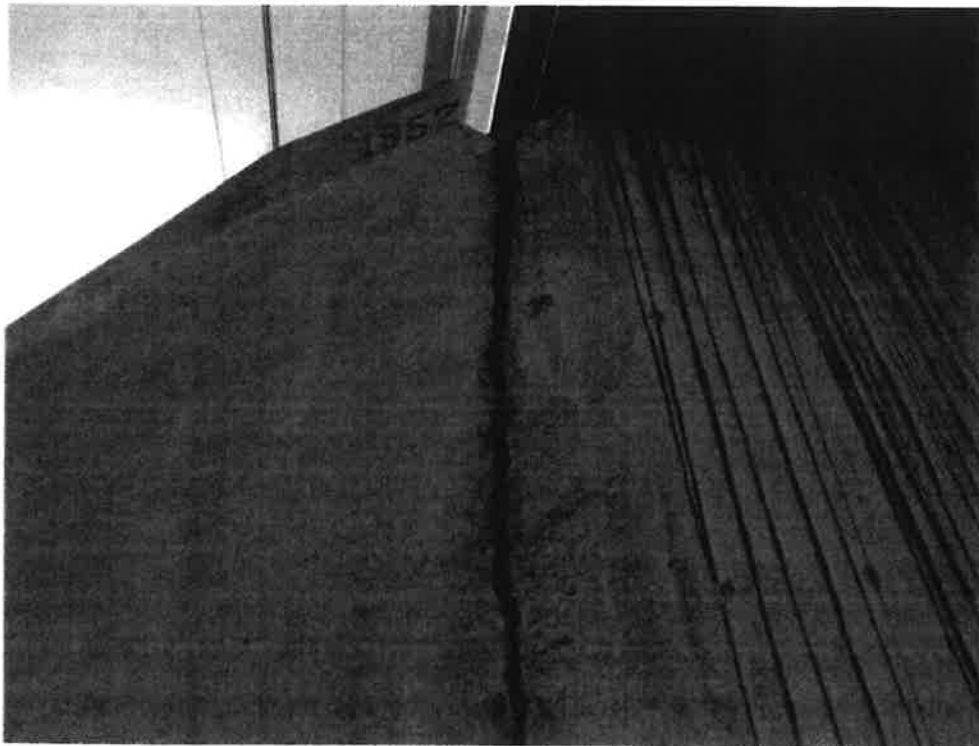
**Photo 12 – Northwest Corner, Large crack and demolished top of wall**

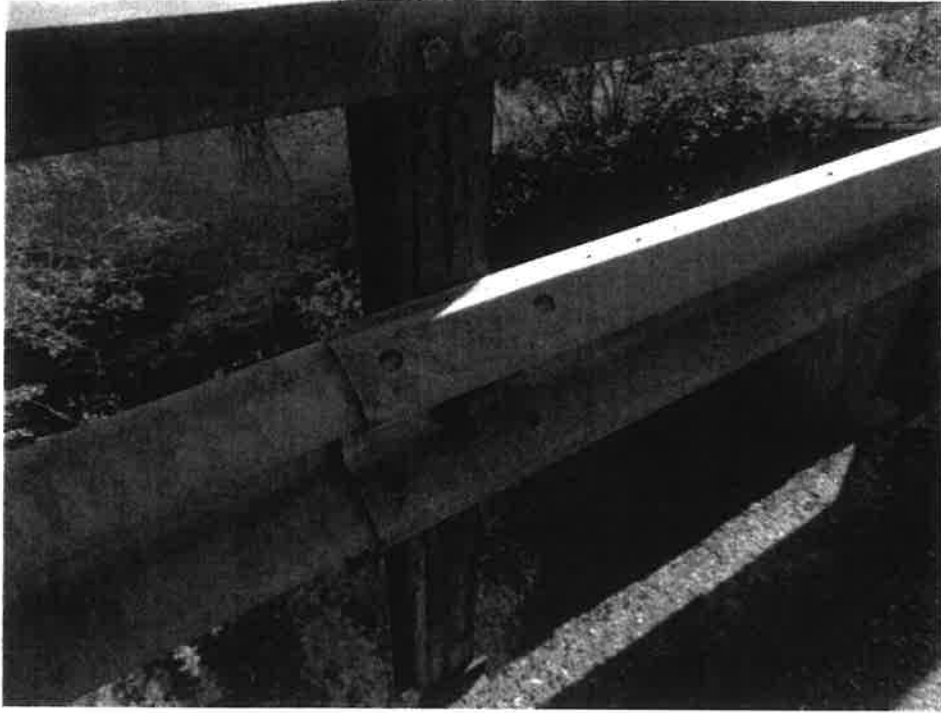
| | RATING | |
|---|---|---|
| APPROACH GUIDE RAIL | <input type="checkbox"/> 5 | Guiderails look intact but there are bolt and nuts missing almost in every piece connections. |

**Photo 13 – Guiderails Missing Bolts at Joints**

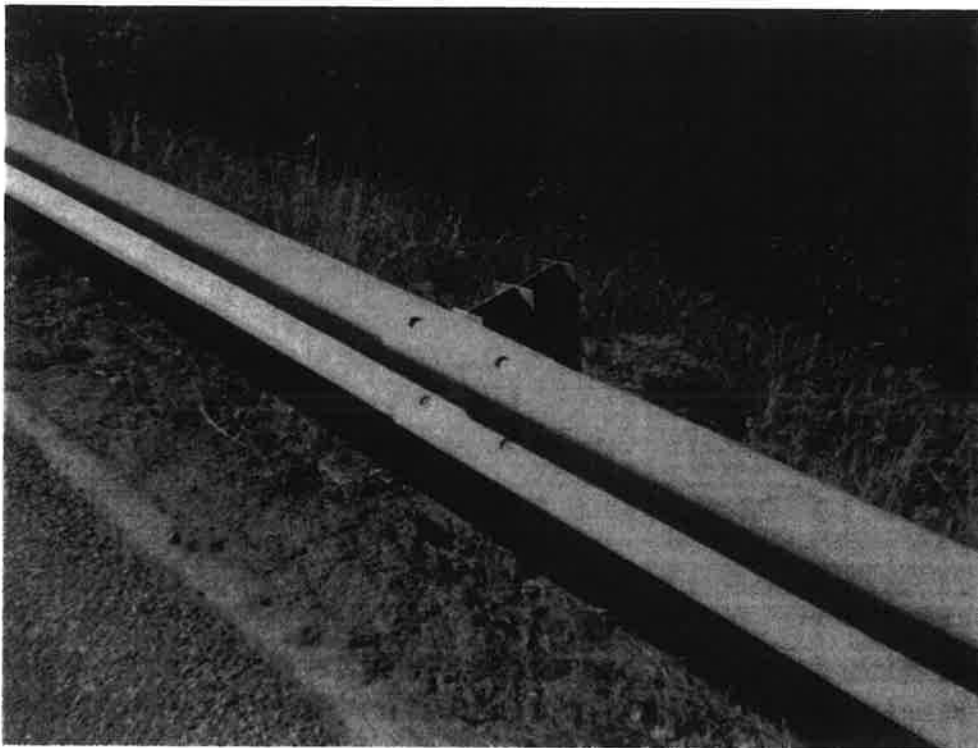
**Photo 14 – Guiderails Missing Bolts at Joints**

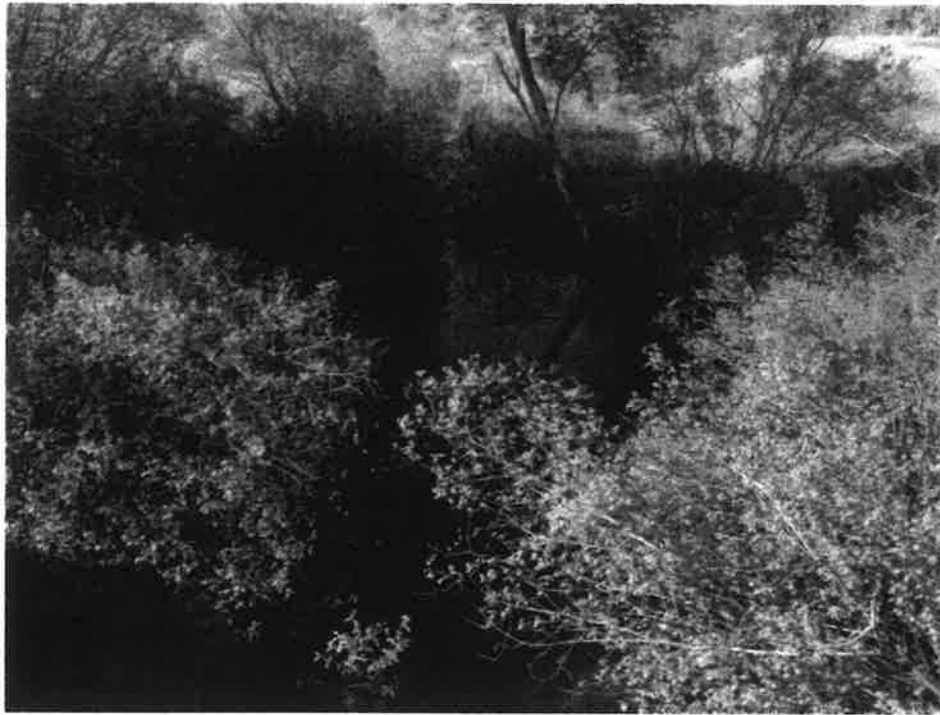
**Photo 15 – Downstream (Looking from Top of Bridge)**

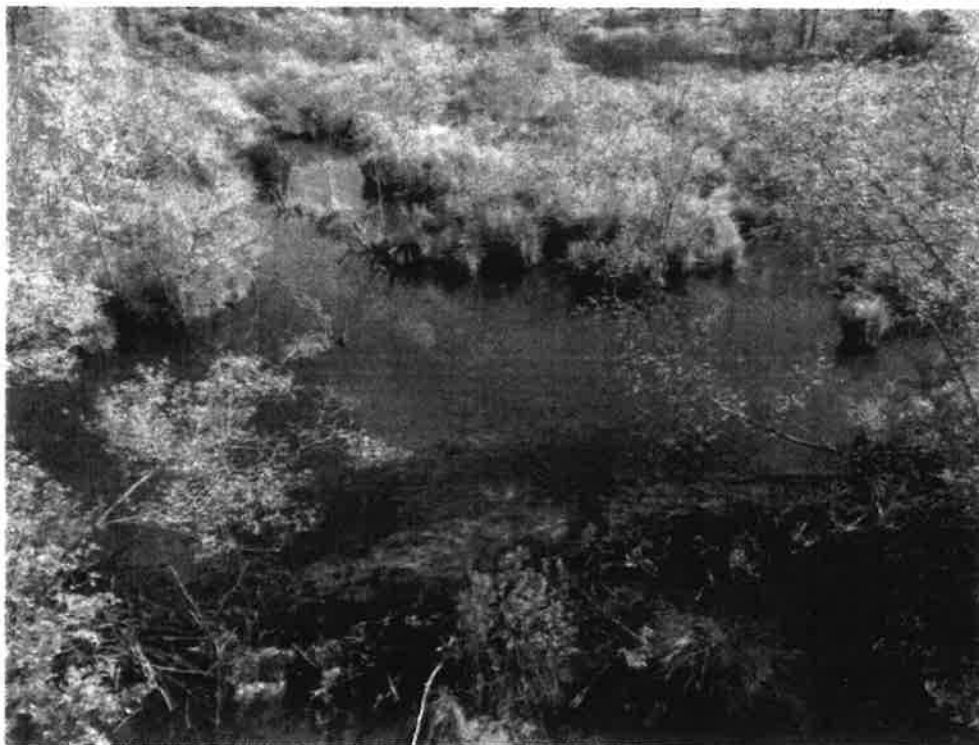
**Photo 16 – Upstream (Looking from Top of Bridge)**
